**Report on the
Investigation of the
Downers Grove Substation Fire**

The Staff of the Illinois Commerce Commission

December 16, 2005

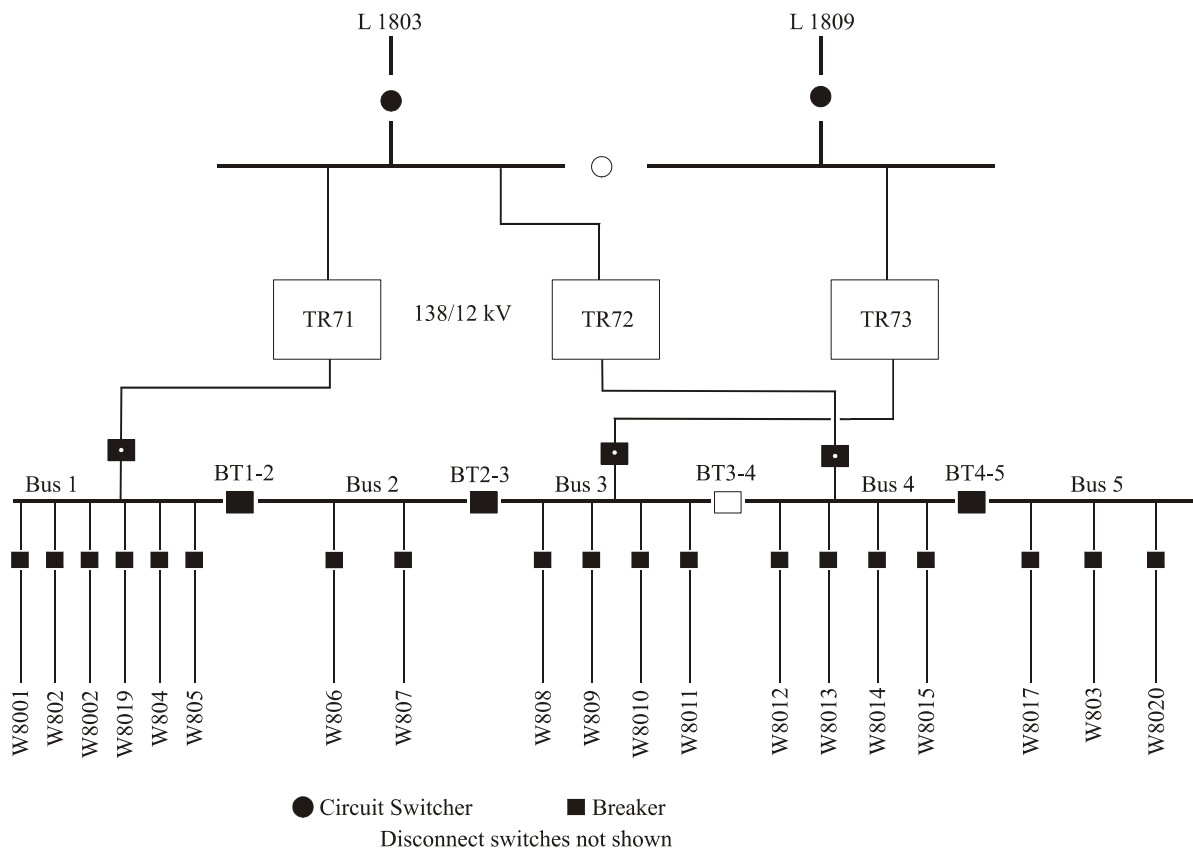
order to coordinate distribution fuses with the station circuit breakers. Feeder W805 had older style electro-mechanical, time-delay, over-current relays on Phases A and B, and the neutral. The neutral relay provided protection for phase C faults and backed up relays on the other phases for ground faults.⁹¹ In case transitory events such as a lightning strike caused a fault, the feeders had reclosing relays that caused feeder breakers to close and re-energize feeders 2 seconds and 30 seconds after the initial trip. When a breaker tripped after reclosing twice it locked out, or stopped trying to re-energize the feeder. ComEd last tested the relays for W805 in August of 1998. After the fire, ComEd determined that the over-current relays operated properly but that the W805 reclosing relay malfunctioned. The diagram below is a simplified drawing of the Downers Grove substation.⁹²
